Modification Needed

CECOM Safety-of-Use message (SOUM) 92-02-01 on the OE-254 antenna, NSN 5985-01-063-1574, came out when many units were deployed to Operation Desert Storm, so lots of folks missed it. Here's the scoop:

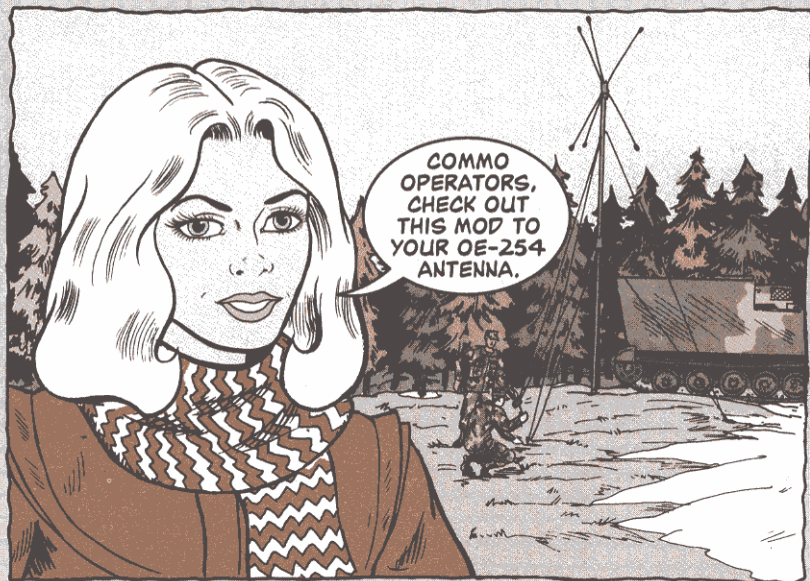
Before you turn in the antenna mast section poles for MWO 11-5985-357-30-1, inspect them for stress cracks at the squared corners of the notch. If poles have any cracks that extend more than 2 1/2 inches from the bottom of the pole, they can't be modified, so turn 'em in and get new ones.

Next, check to see if any of those good mast sections still have tabs and notches. If so, turn them in to DS for the MWO.

The finished mast will be one section shorter, but will transmit as well as ever. The MWO will make the antenna system last longer, too.
